The Limits of Restoration: Getting to Know the True Nature of Your Stream Valley and Hopefully Keeping It Intact!

2017 MAIPC/SERMA Conference

Rod Simmons, Natural Resource Manager
City of Alexandria Dept. Recreation, Parks, and Cultural Activities,
Natural Resources Division

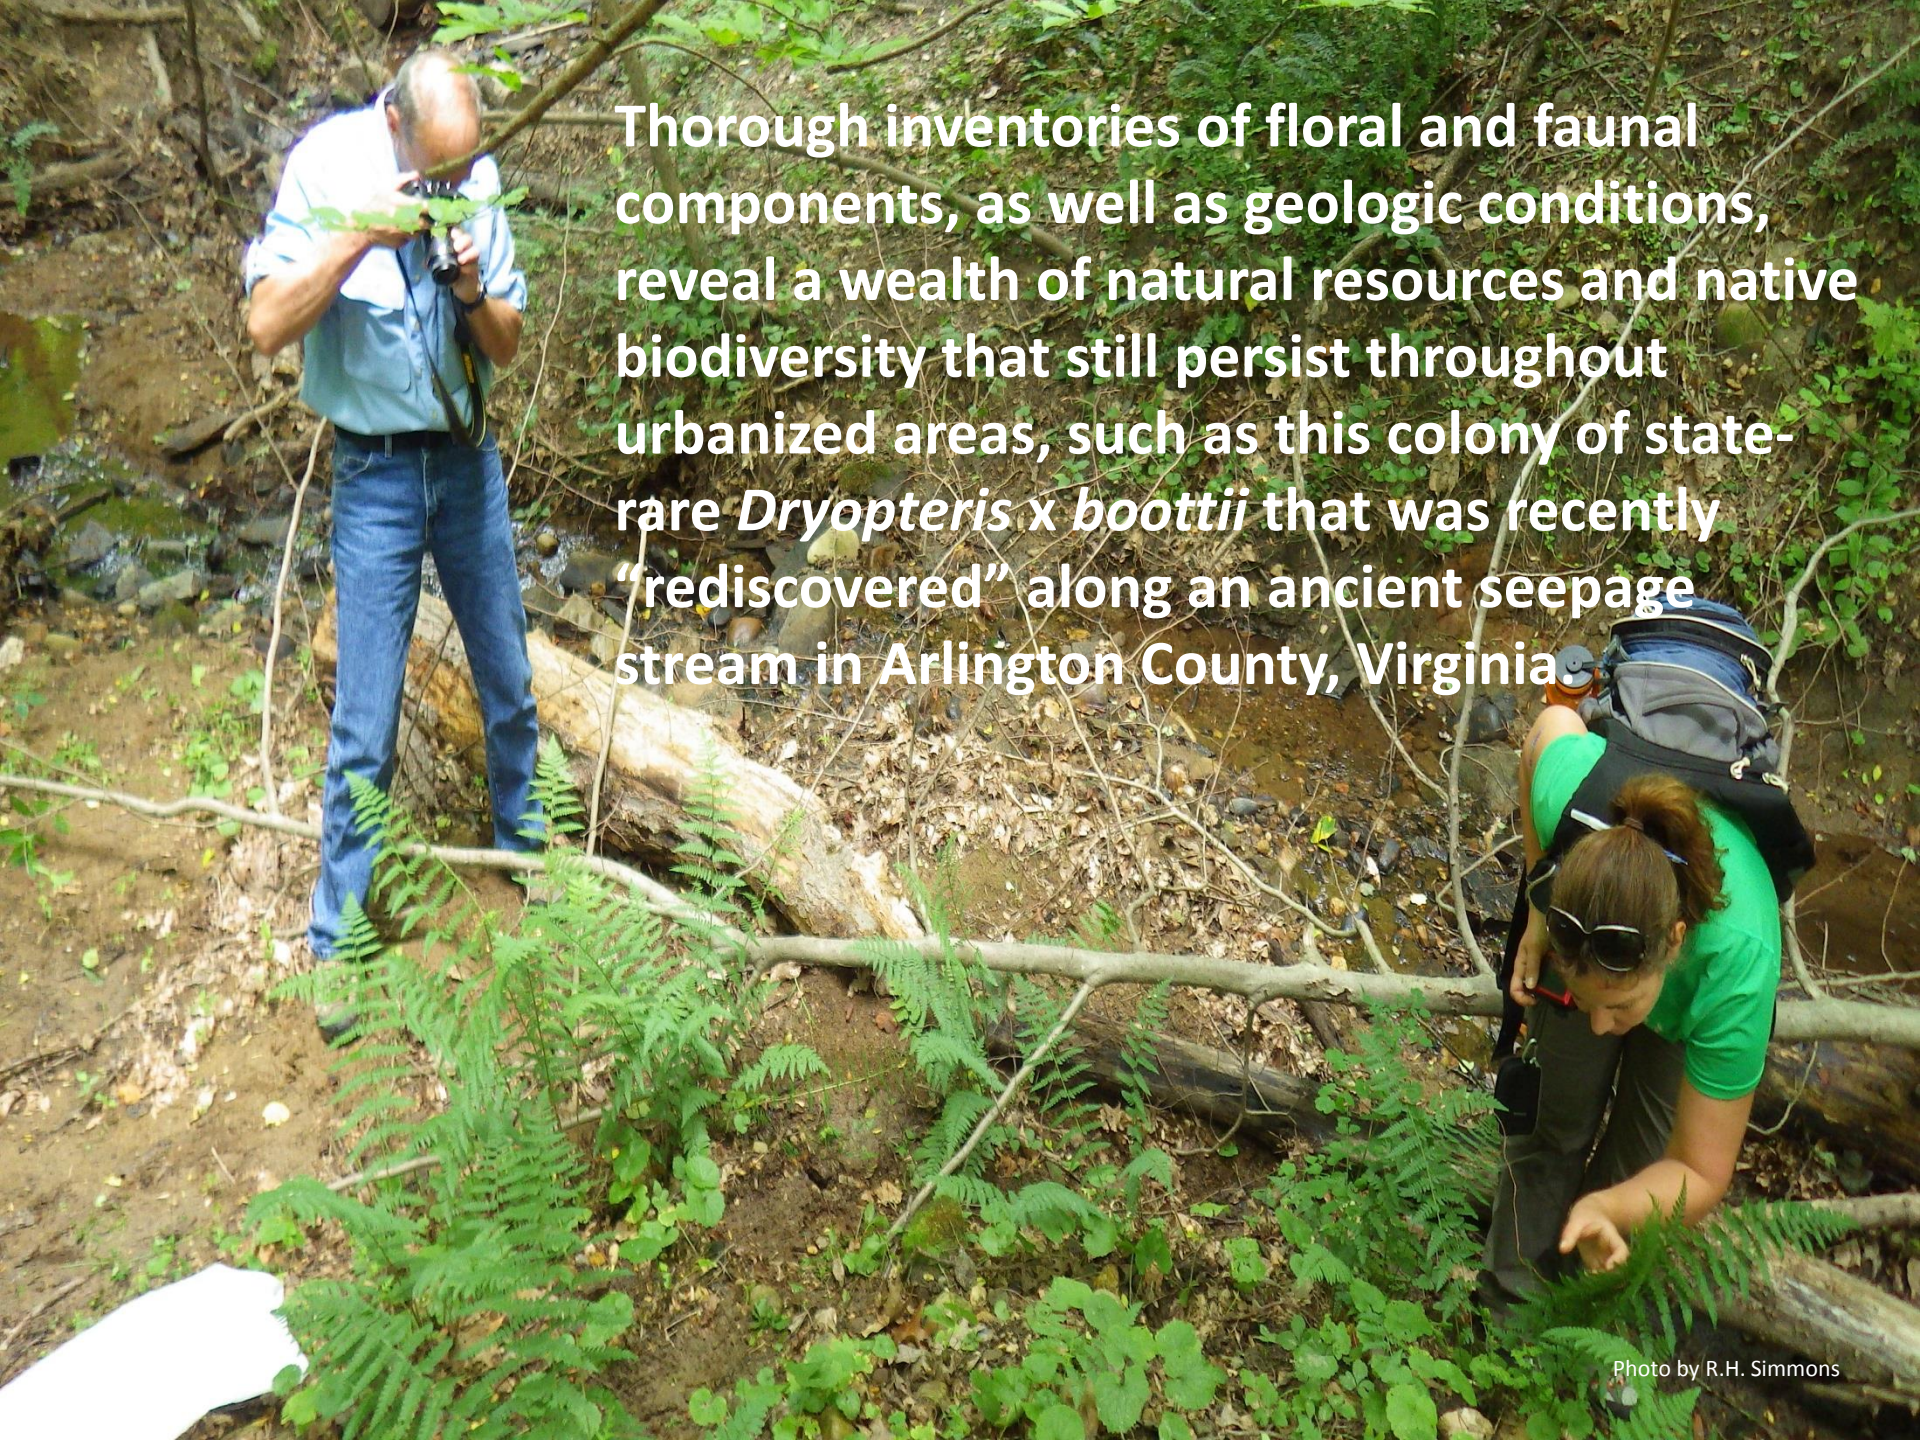
Thorough inventories of floral and faunal components, as well as geologic conditions, reveal a wealth of natural resources and native biodiversity that still persist throughout urbanized areas, such as this colony of state-rare *Dryopteris x boottii* that was recently “rediscovered” along an ancient seepage stream in Arlington County, Virginia.

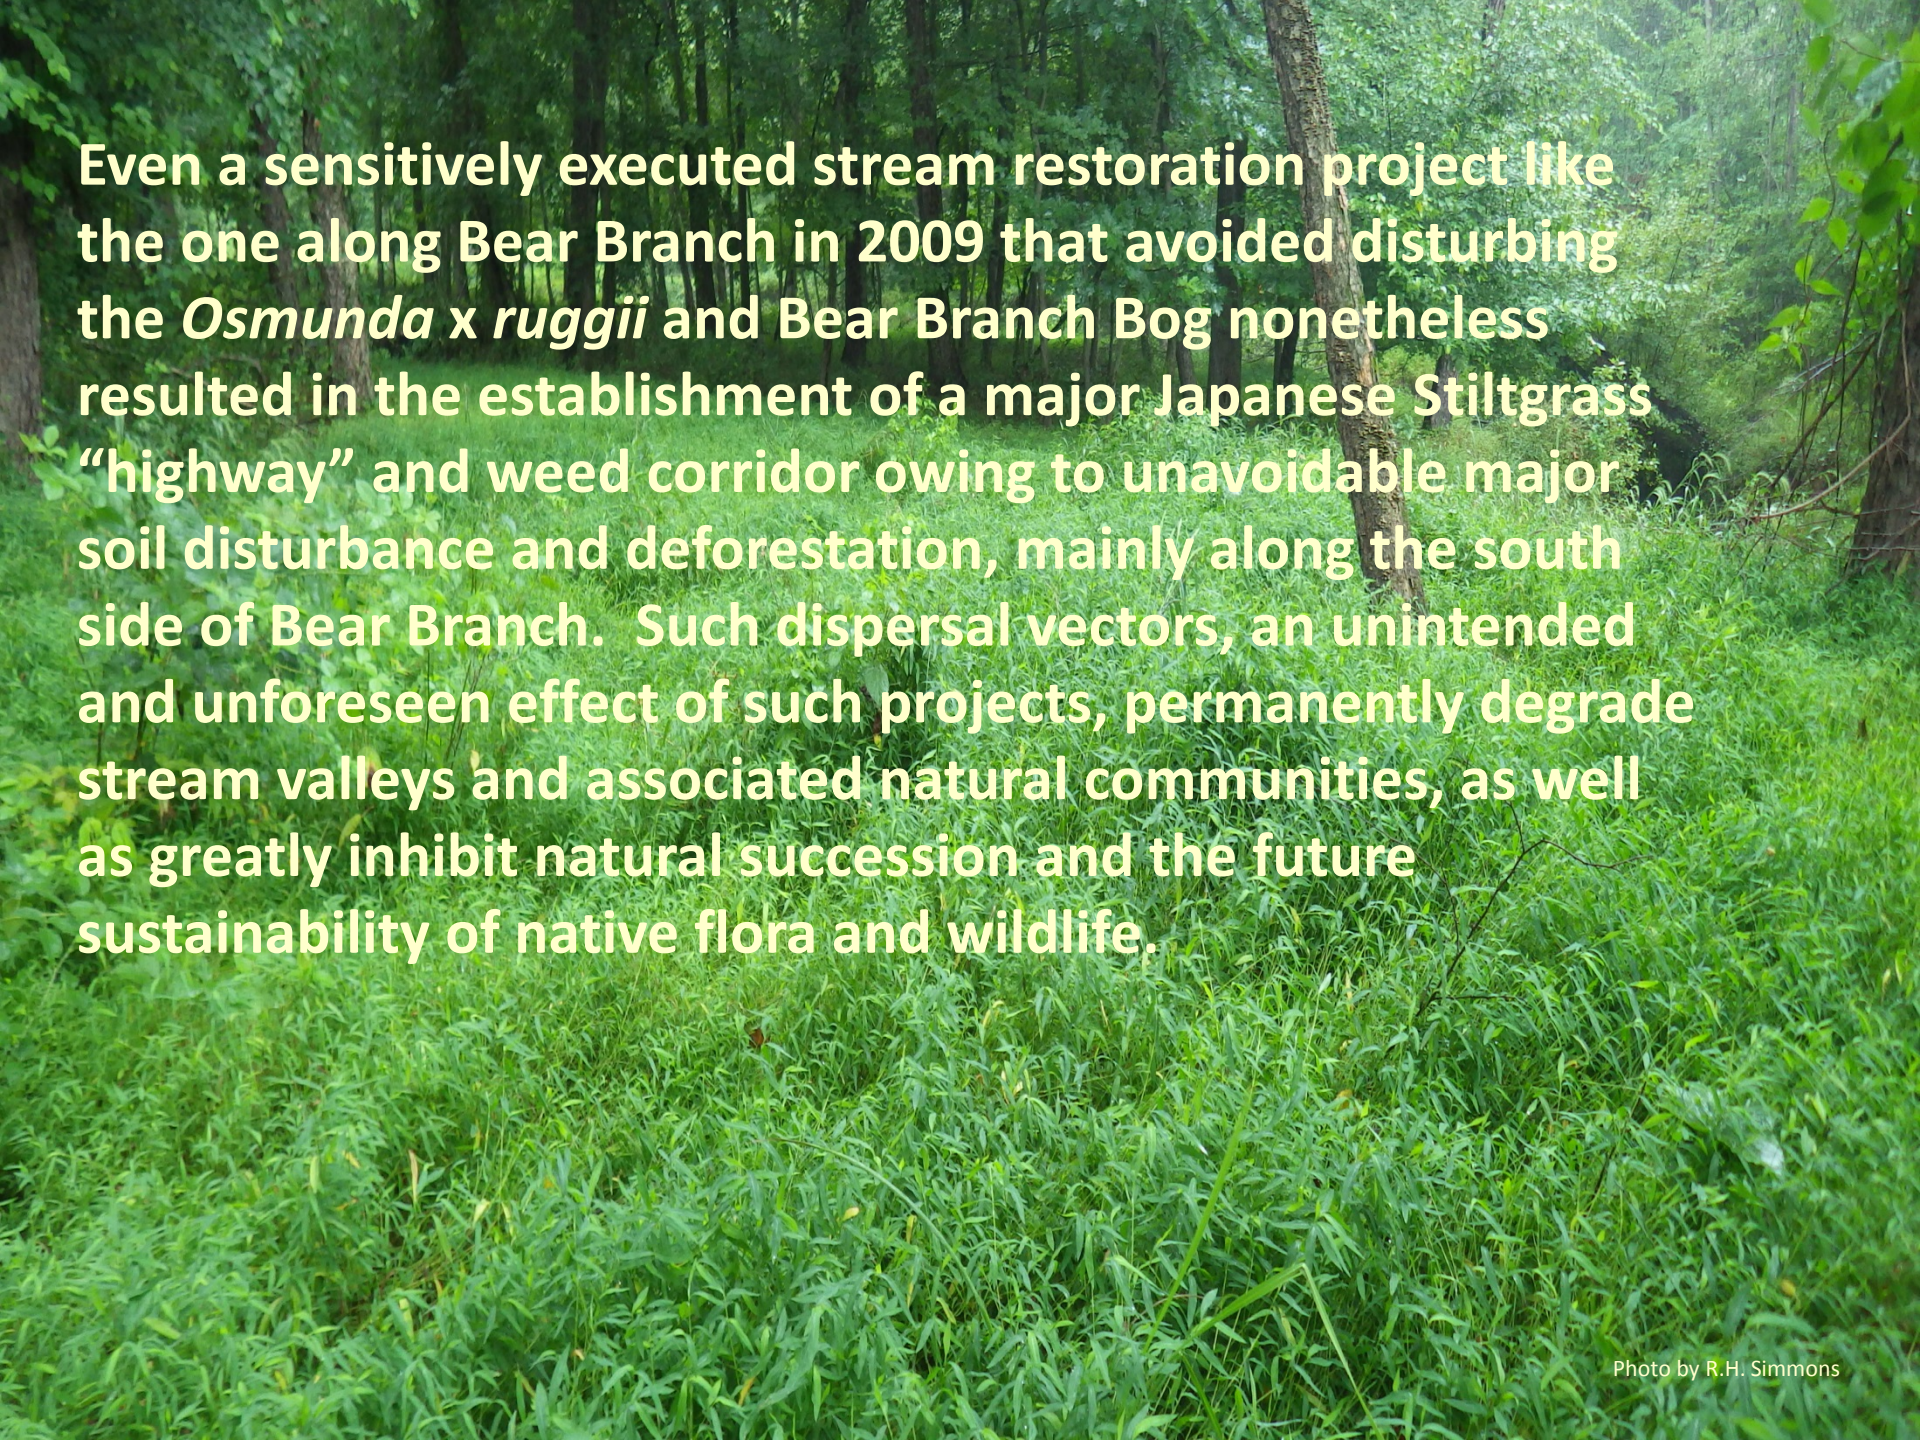
A photograph of a lush green forest. In the foreground, there is a dense field of tall, green grasses and weeds, which is the subject of the text. In the background, a stream flows through a wooded area with many trees and more greenery. The overall scene is a natural, somewhat overgrown stream valley.

Even a sensitively executed stream restoration project like the one along Bear Branch in 2009 that avoided disturbing the *Osmunda x ruggii* and Bear Branch Bog nonetheless resulted in the establishment of a major Japanese Stiltgrass “highway” and weed corridor owing to unavoidable major soil disturbance and deforestation, mainly along the south side of Bear Branch. Such dispersal vectors, an unintended and unforeseen effect of such projects, permanently degrade stream valleys and associated natural communities, as well as greatly inhibit natural succession and the future sustainability of native flora and wildlife.

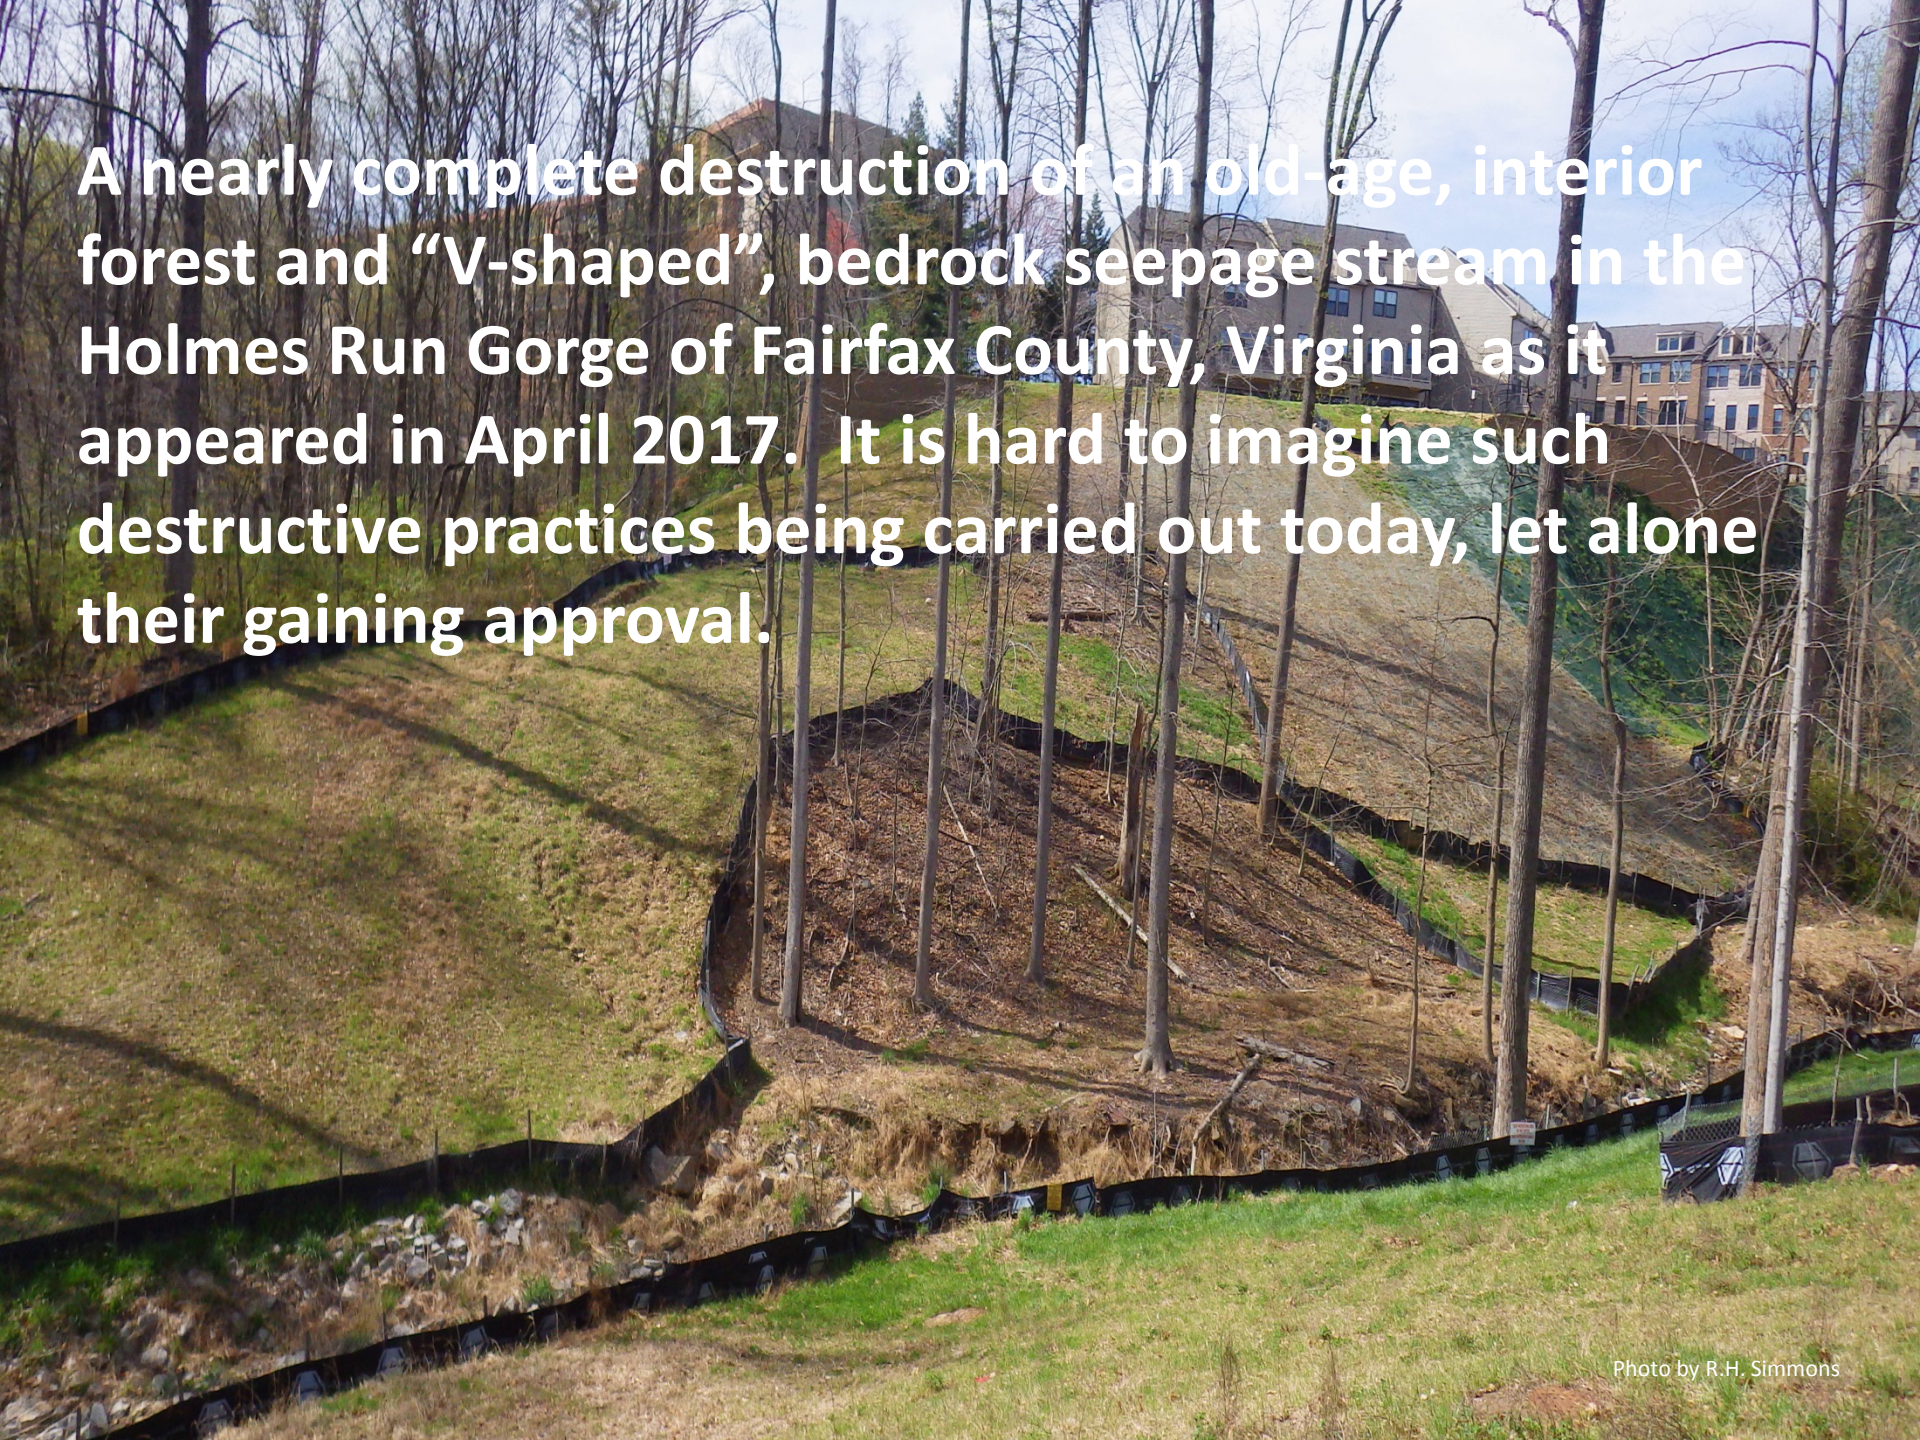
A nearly complete destruction of an old-age, interior forest and “V-shaped”, bedrock seepage stream in the Holmes Run Gorge of Fairfax County, Virginia as it appeared in April 2017. It is hard to imagine such destructive practices being carried out today, let alone their gaining approval.

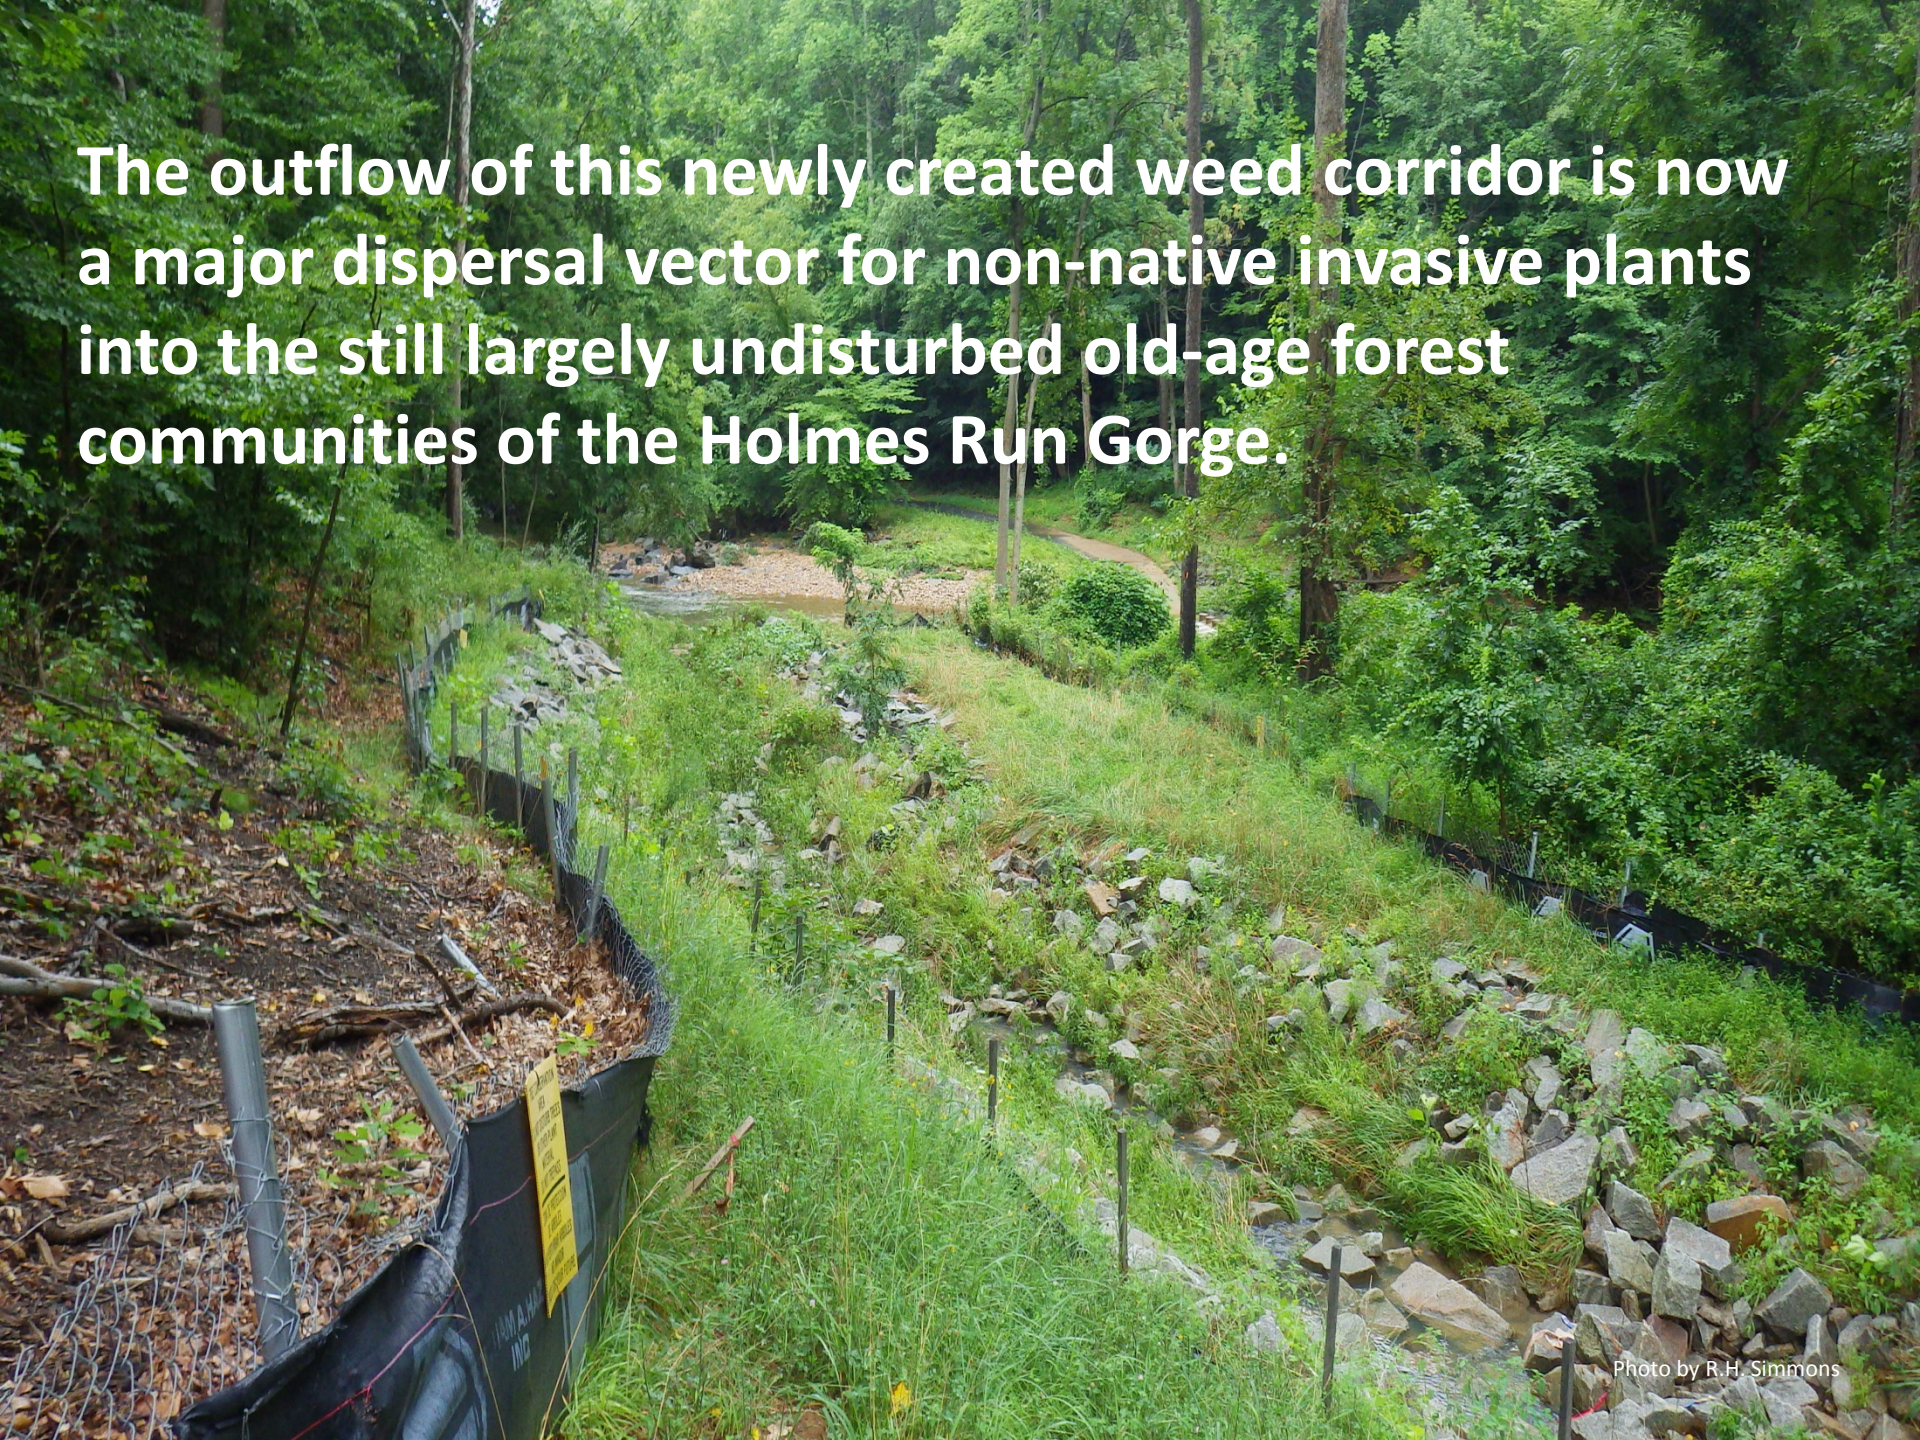
A photograph of a stream valley. The stream flows through a channel lined with large, dark grey rocks. The banks are covered in lush green vegetation, including various grasses and leafy plants. Several trees are visible, with a prominent one on the right side. A chain-link fence runs along the right bank. In the background, a black mesh fence is visible on a hillside. The overall scene is a densely vegetated stream valley.

The same largely deforested and disturbed stream valley in July 2017 completely overrun with Japanese Stiltgrass, Wineberry, Oriental Bittersweet, and other pervasive, difficult to control weeds.

The outflow of this newly created weed corridor is now a major dispersal vector for non-native invasive plants into the still largely undisturbed old-age forest communities of the Holmes Run Gorge.

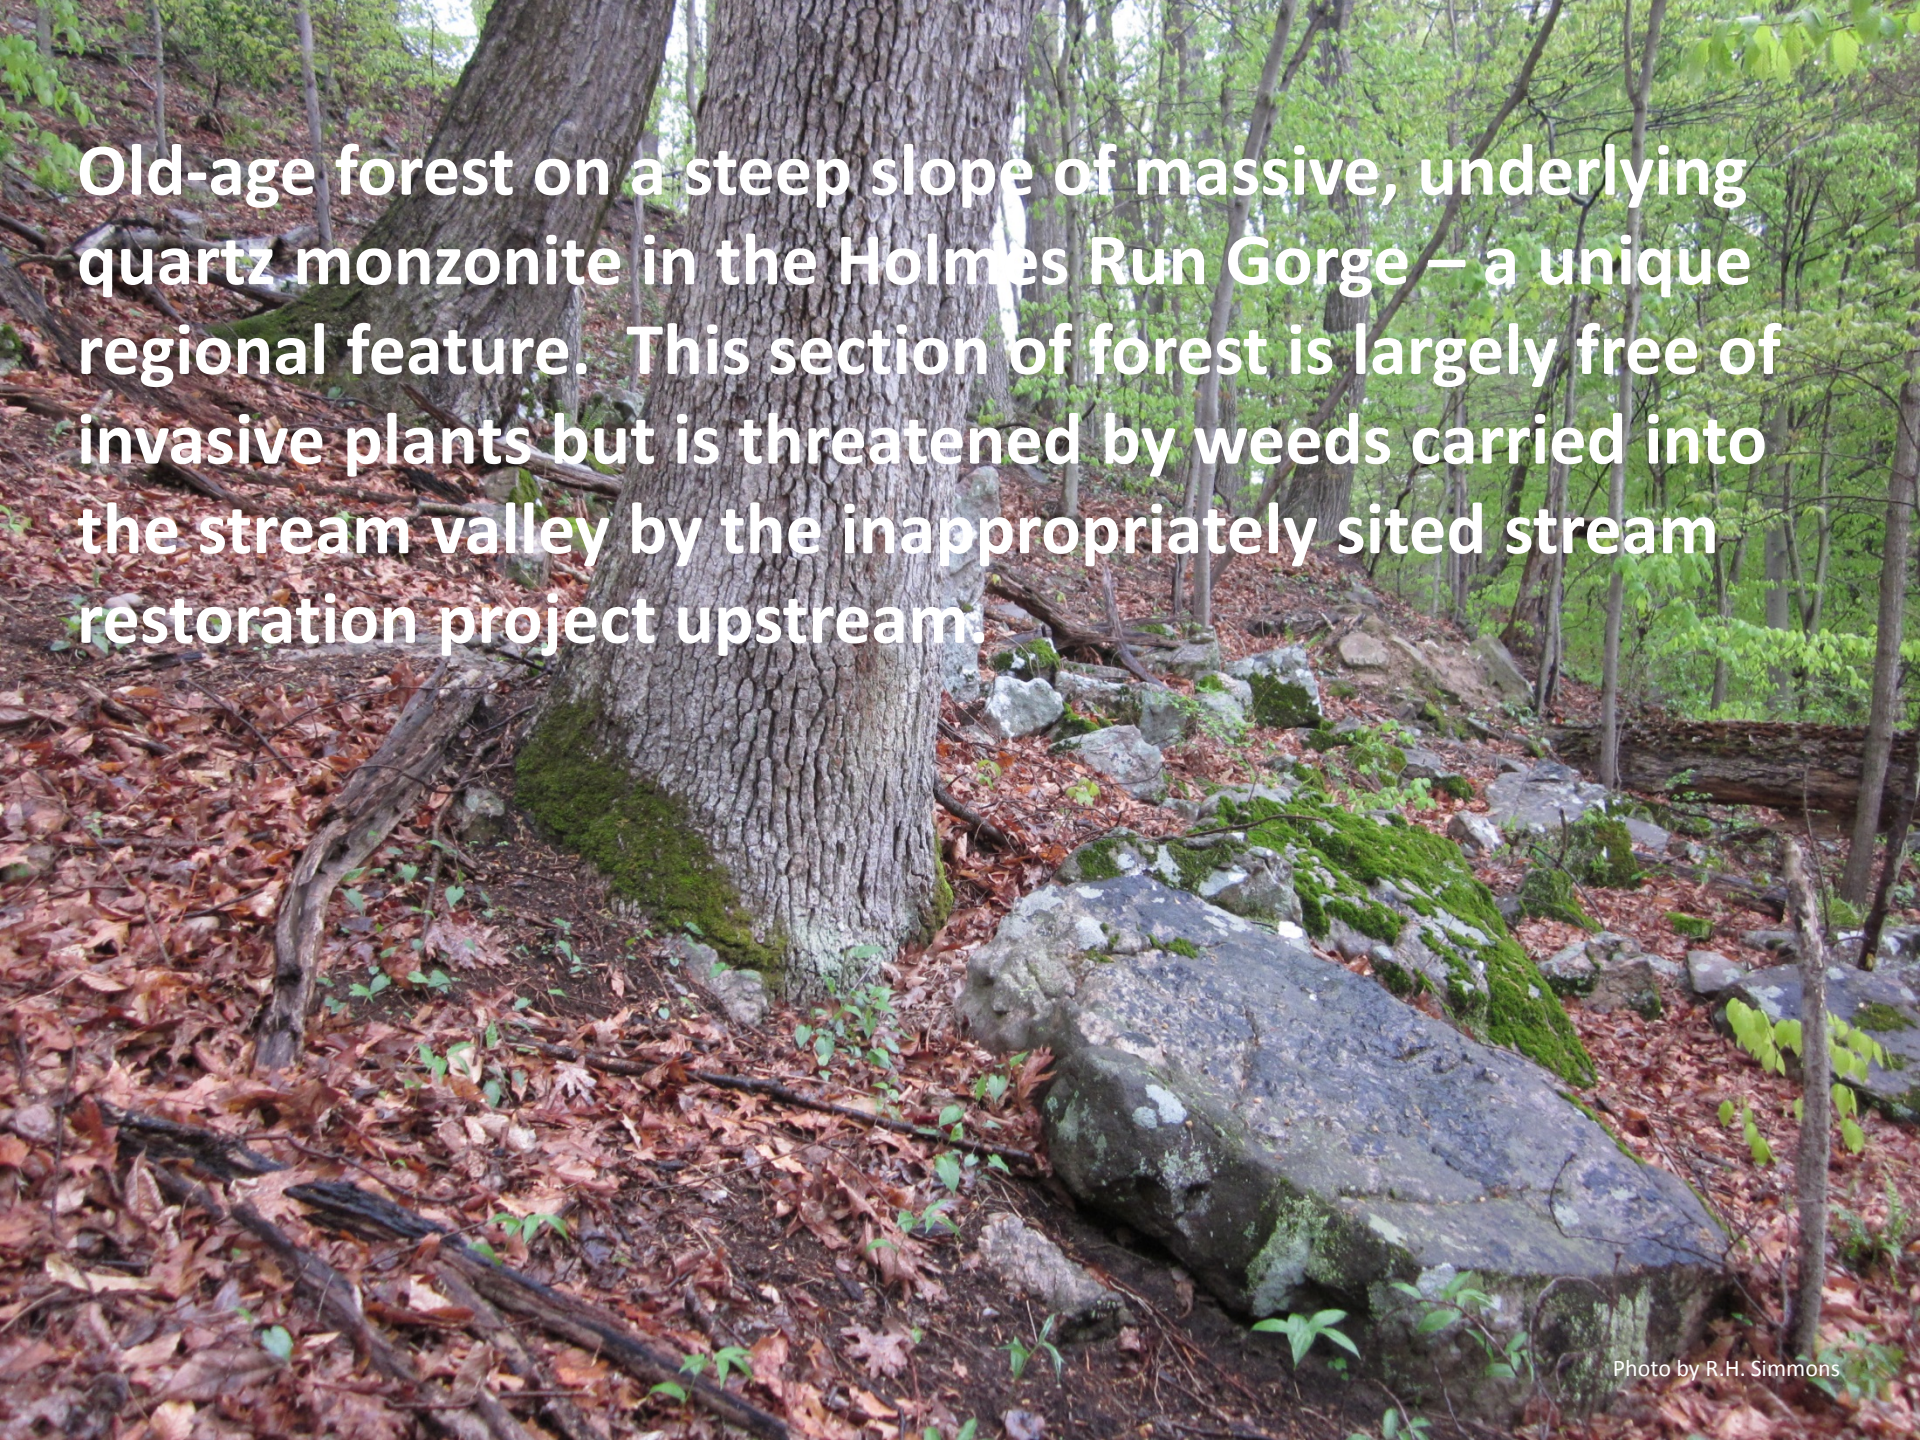
Old-age forest on a steep slope of massive, underlying quartz monzonite in the Holmes Run Gorge – a unique regional feature. This section of forest is largely free of invasive plants but is threatened by weeds carried into the stream valley by the inappropriately sited stream restoration project upstream.

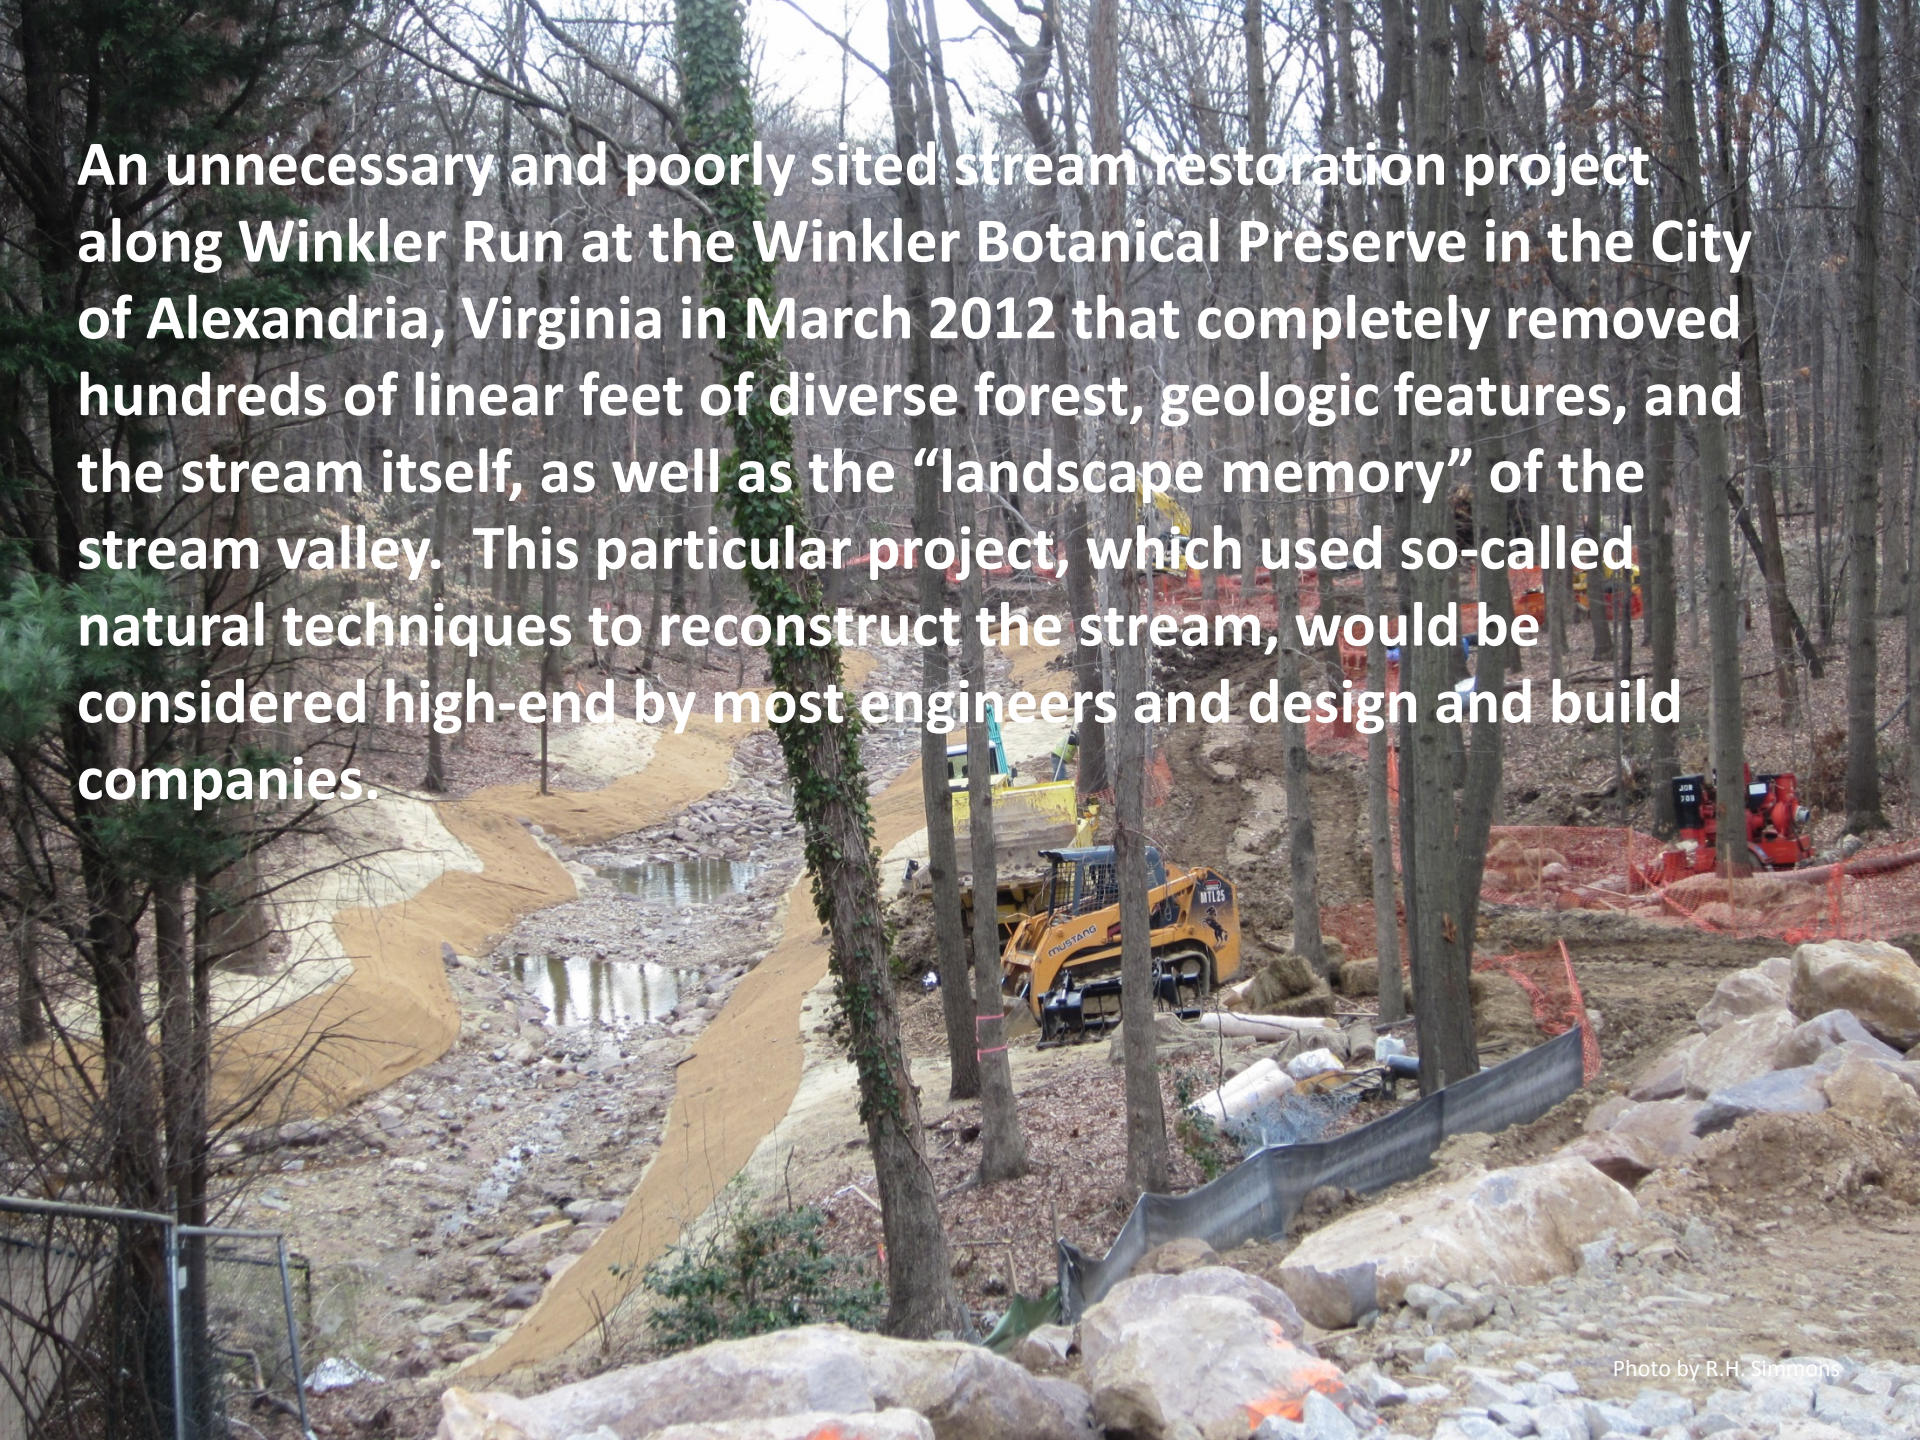
An unnecessary and poorly sited stream restoration project along Winkler Run at the Winkler Botanical Preserve in the City of Alexandria, Virginia in March 2012 that completely removed hundreds of linear feet of diverse forest, geologic features, and the stream itself, as well as the “landscape memory” of the stream valley. This particular project, which used so-called natural techniques to reconstruct the stream, would be considered high-end by most engineers and design and build companies.

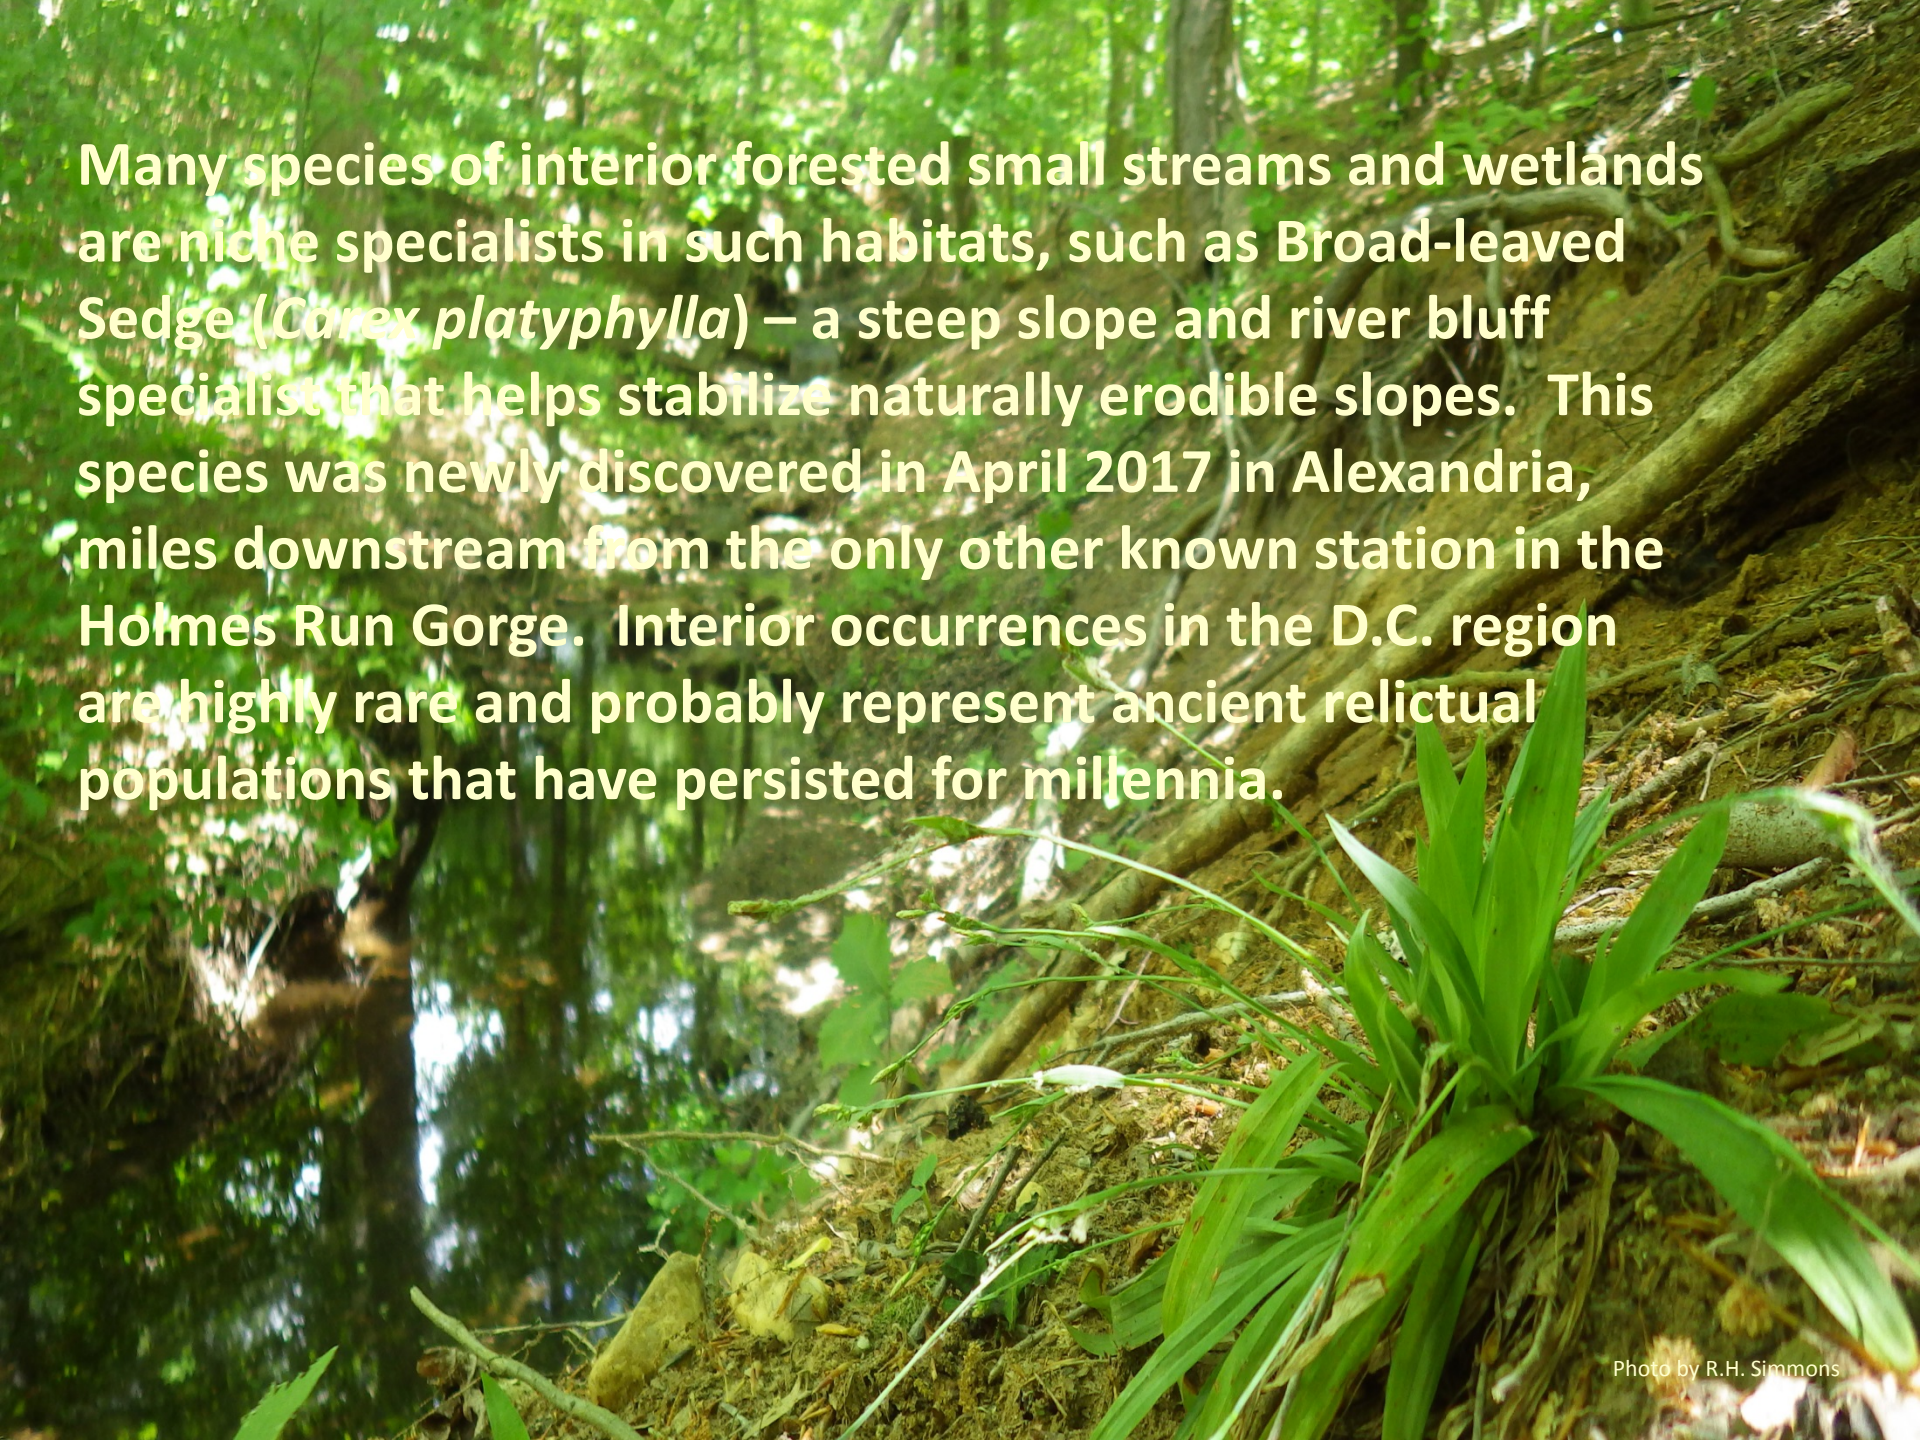
A photograph of a stream bank. In the foreground, a cluster of Broad-leaved Sedge plants with long, narrow, green leaves is growing on a soil bank. The background shows a stream with water reflecting the surrounding green trees and foliage. The scene is a natural, wooded environment.

Many species of interior forested small streams and wetlands are niche specialists in such habitats, such as Broad-leaved Sedge (*Carex platyphylla*) – a steep slope and river bluff specialist that helps stabilize naturally erodible slopes. This species was newly discovered in April 2017 in Alexandria, miles downstream from the only other known station in the Holmes Run Gorge. Interior occurrences in the D.C. region are highly rare and probably represent ancient relictual populations that have persisted for millennia.
